Detection of Structural Components and Seepage Zones at the Eagle Mountain Facility Using Geophysics

**ASDSO 2010
Seattle, WA**

Eagle Mt. Dam & Lake

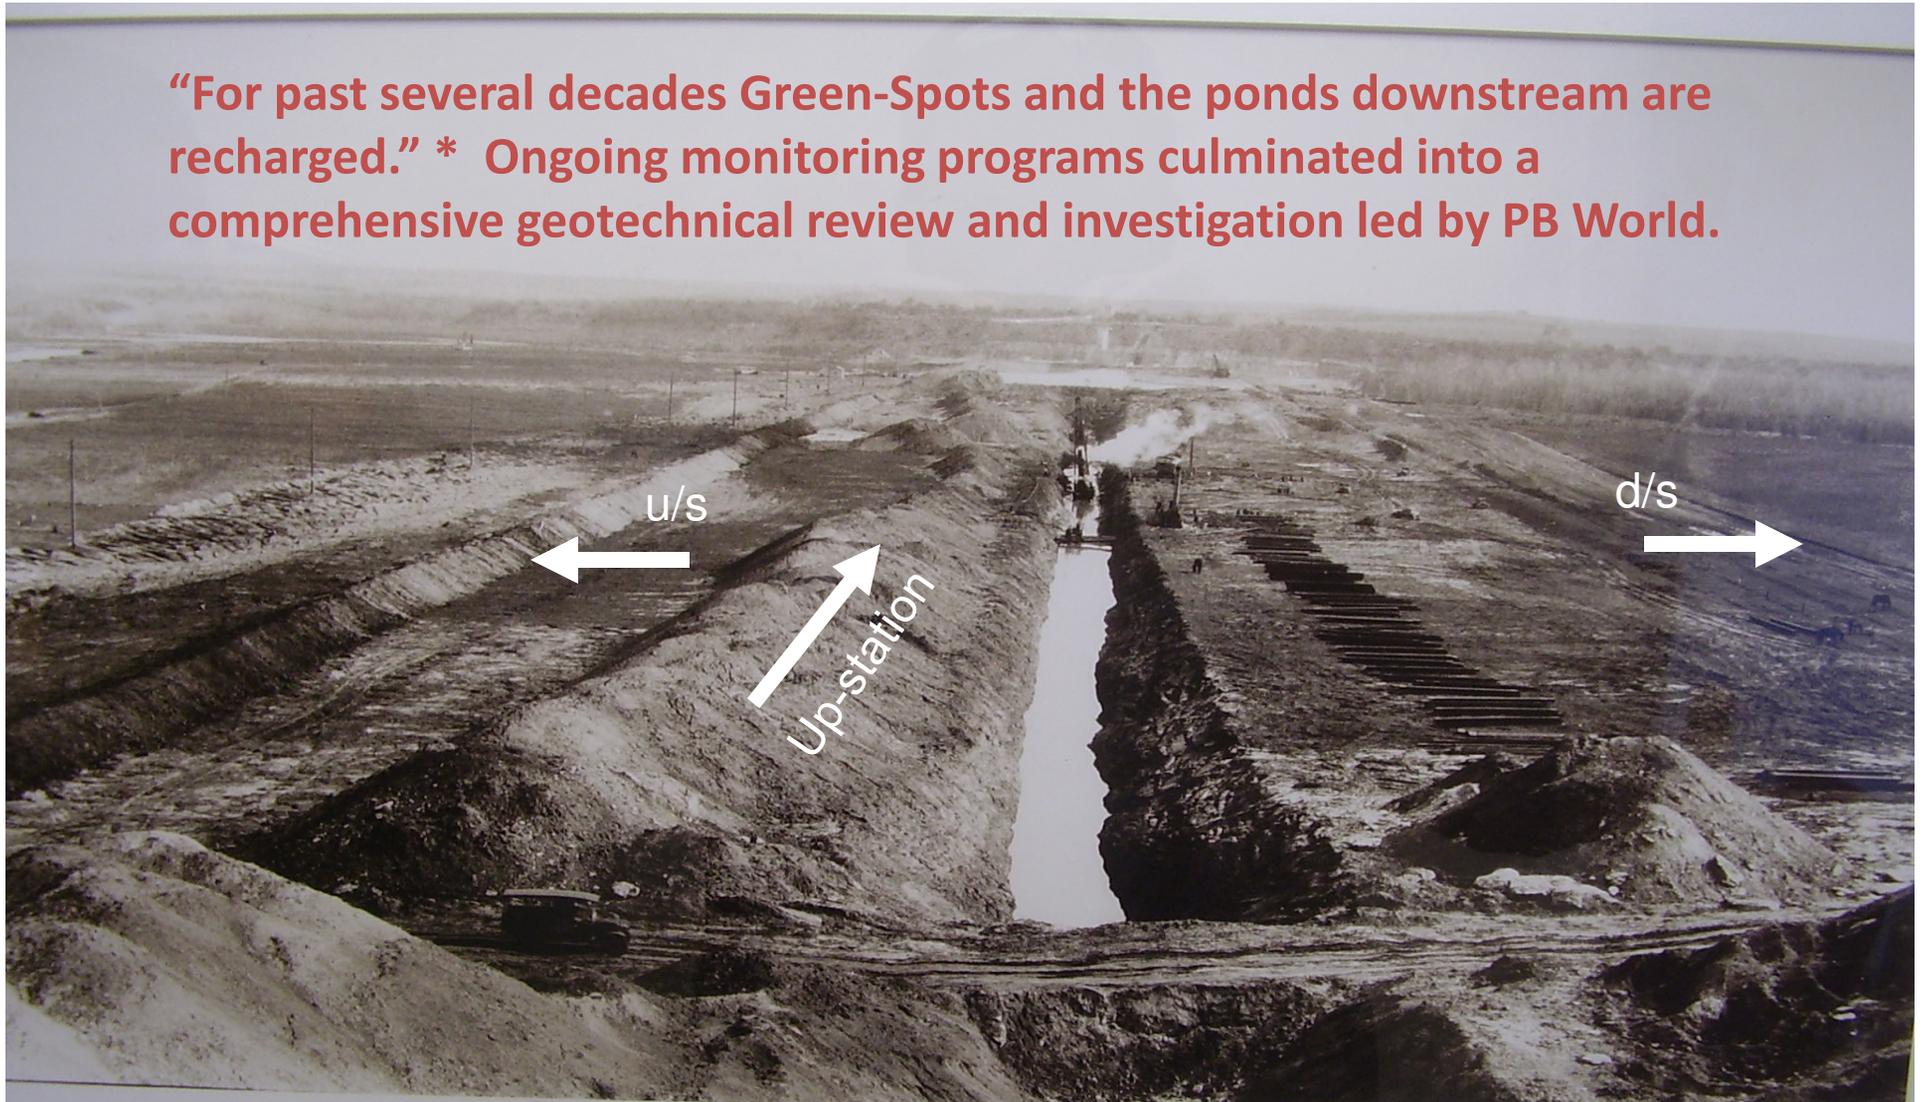
Eagle Mountain Dam Jan. 31, 1931.

“For past several decades Green-Spots and the ponds downstream are recharged.” * Ongoing monitoring programs culminated into a comprehensive geotechnical review and investigation led by PB World.

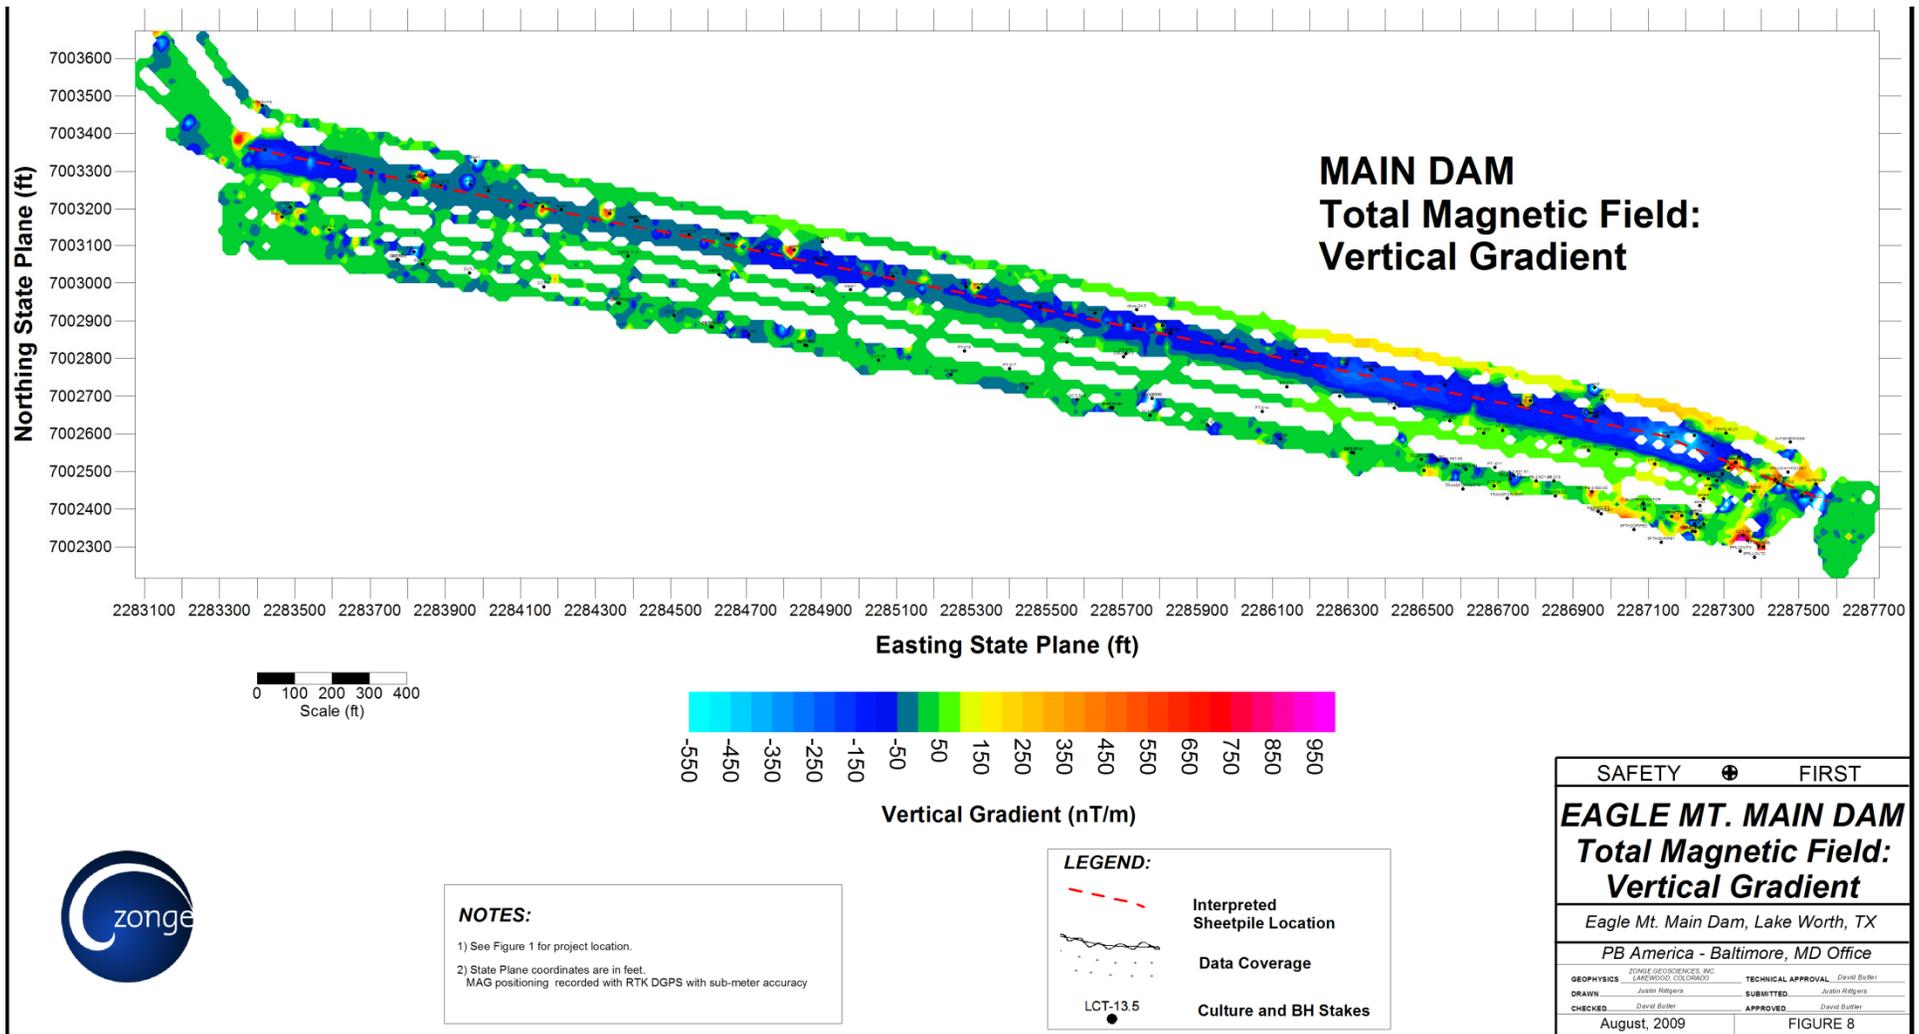
Vertical MAG Gradient- Main Dam

- **Magnetics:**
 - Mapped the position and lateral extent of sheet-piling – full length of structure - as well as some cultural features that helped place the ERI lines.
- **SP:**
 - Mapped one broad anomaly perpendicular to the main dam, and has good correlation with ERI results; and one lesser anomaly near the right abutment
- **ERI:**
 - Mapped u/s-d/s “linear” anomalies coincident with the SP anomaly location.

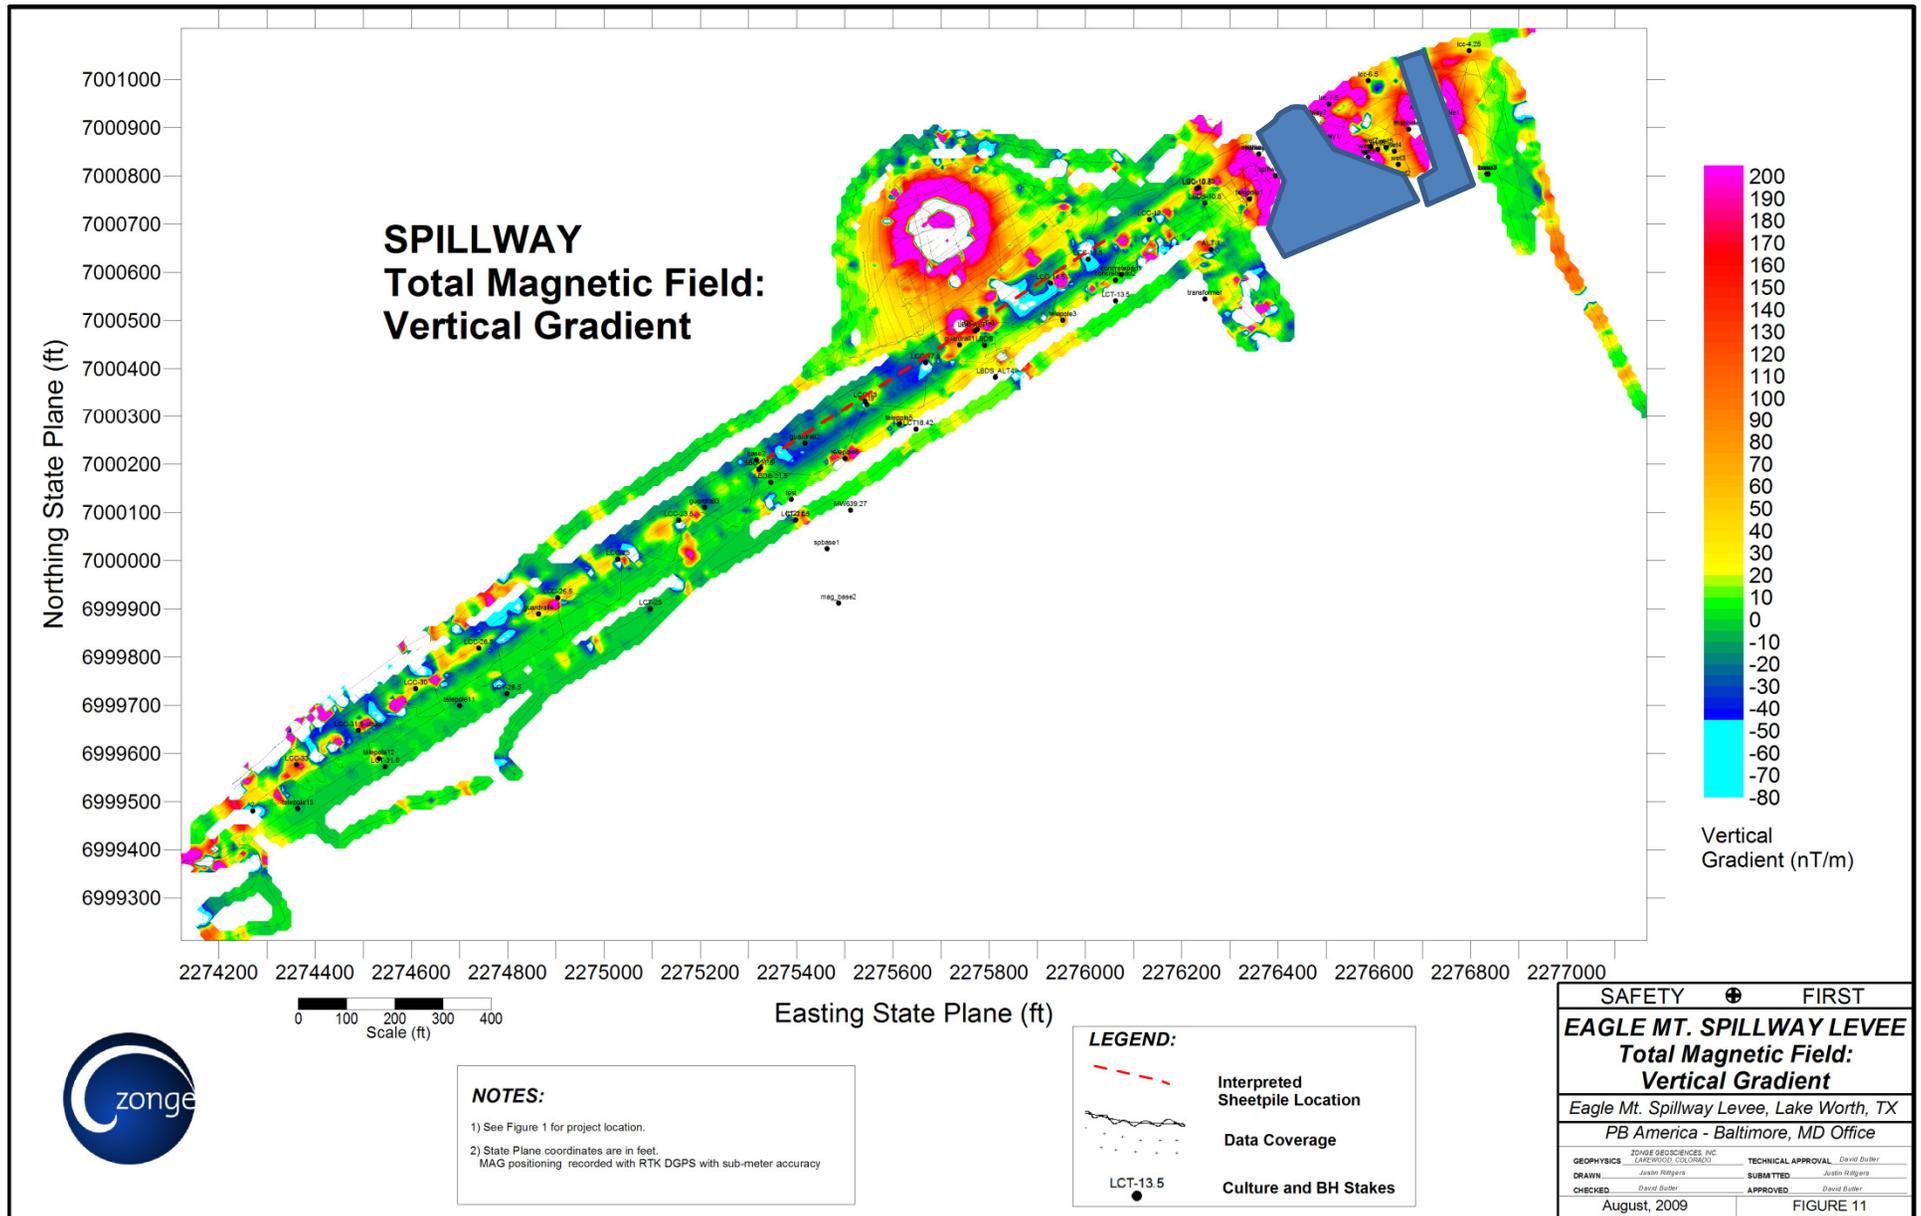
Vertical MAG Gradient- Spillway Levee

- Mapped position and lateral extent of sheet-piling beneath the levee structure – **NOT ENTIRE LENGTH!** Also, helped identify buried cultural features that helped with placement of ERI lines.

- Confirmed the presence and location of an abandoned morning glory structure very well.

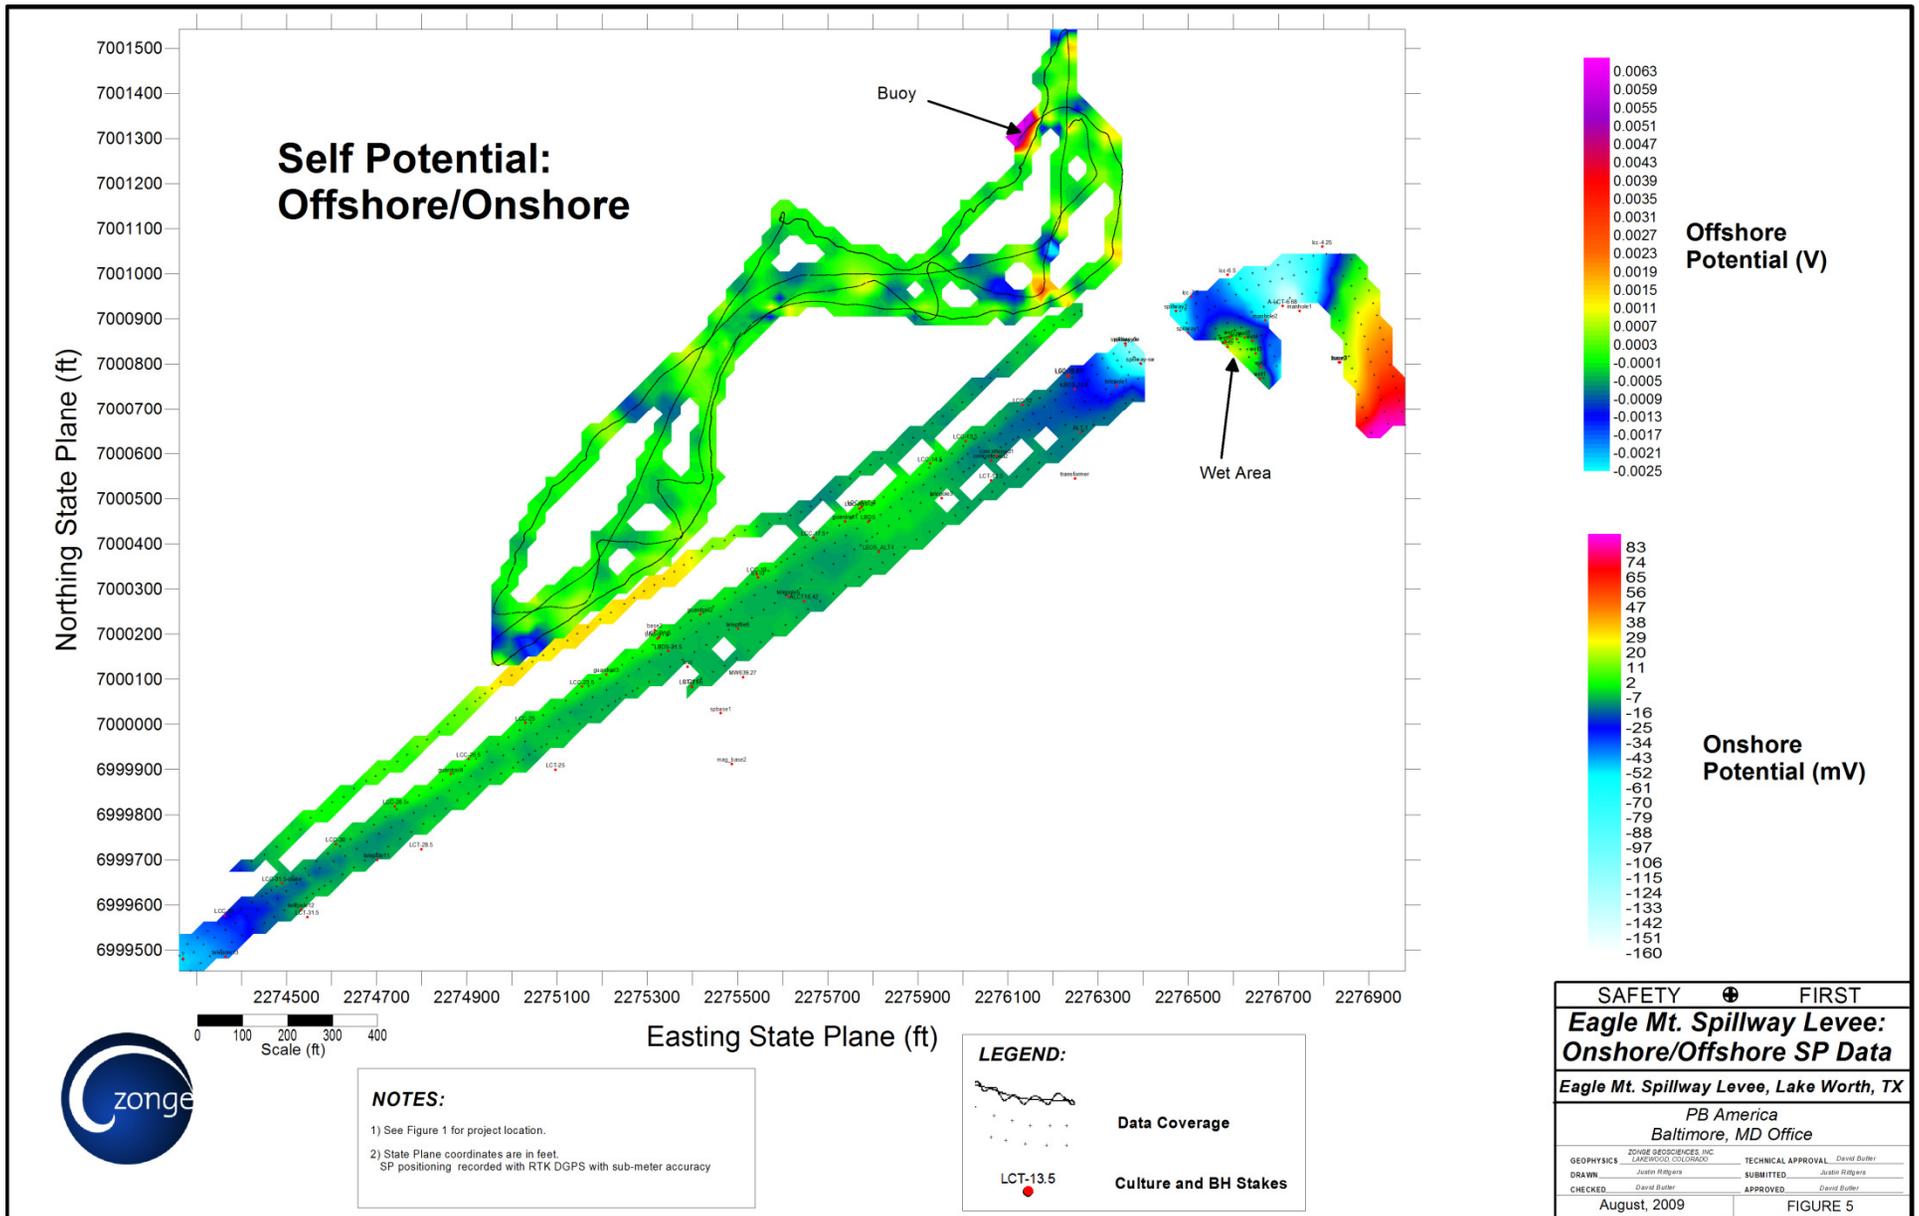
Self Potential- Spillway Levee

- Mapped one small / broad anomaly perpendicular to the levee west of the morning glory area and end of the sheet piling wall

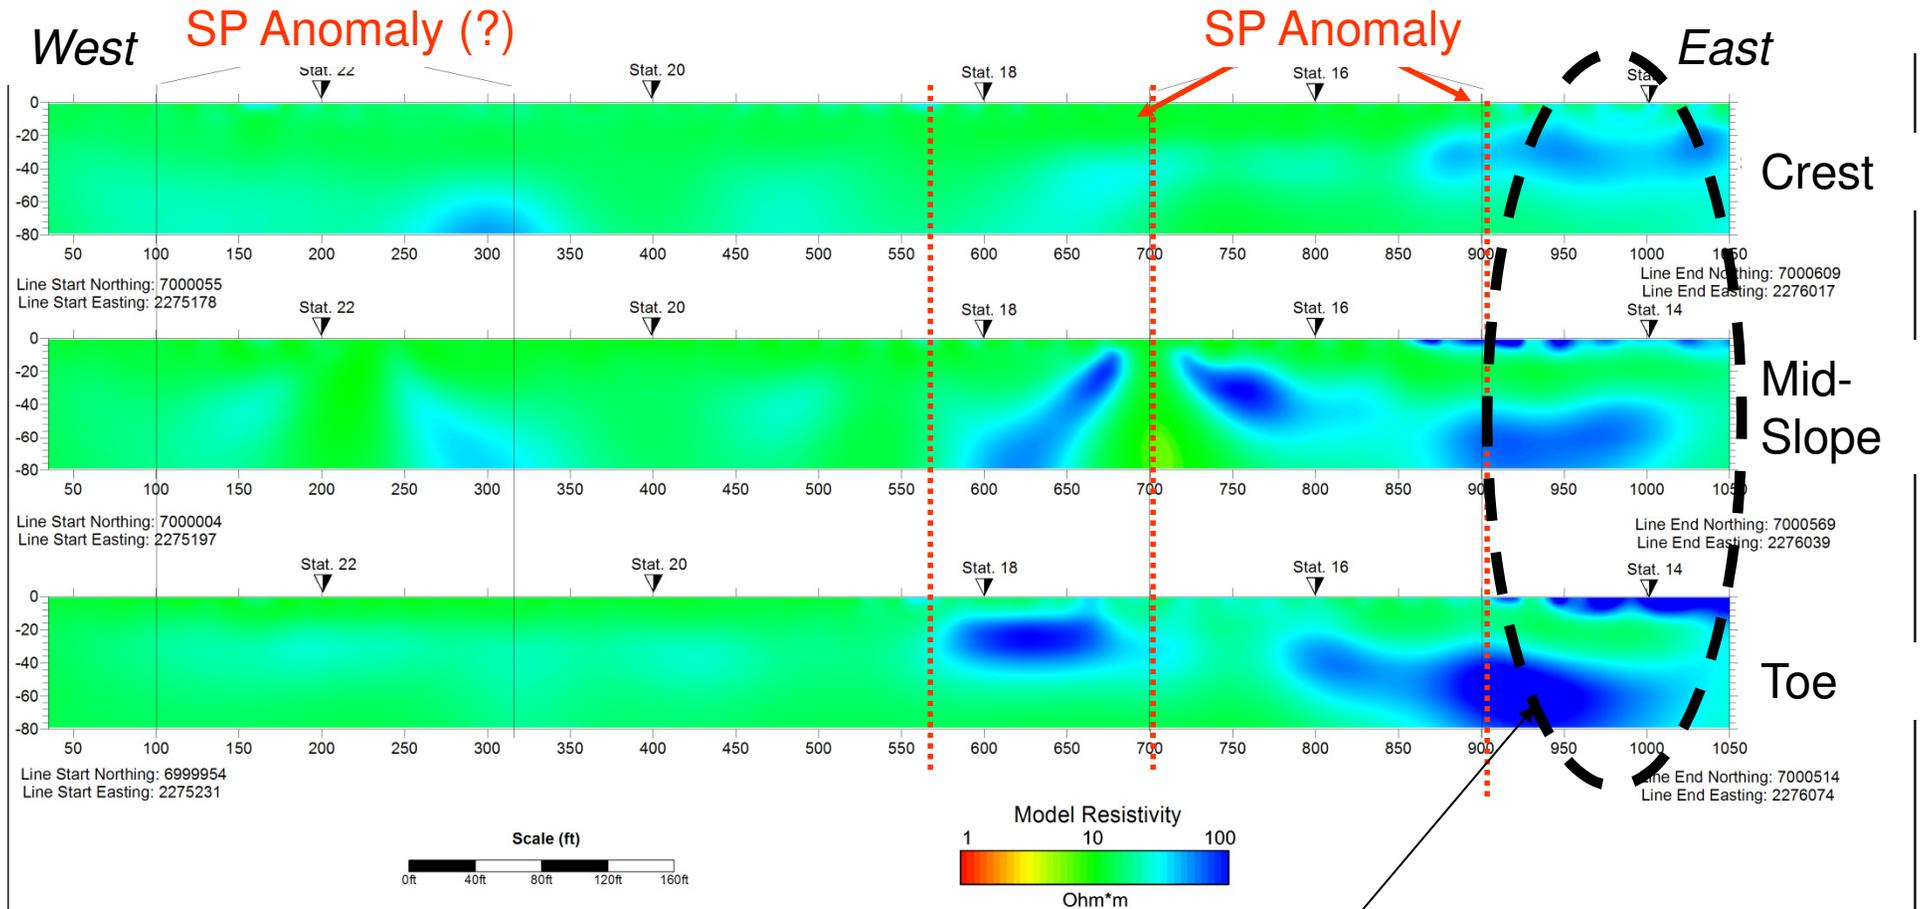
Electrical Resistivity- Spillway Levee

ERI Data Influenced by MG Structure (?)

- Mapped linear anomalies coincident with the main dam's SP anomaly location, and at other suspect portions of the spillway structure
