Rio Nuevo North

Buried Landfill Delineation with IP

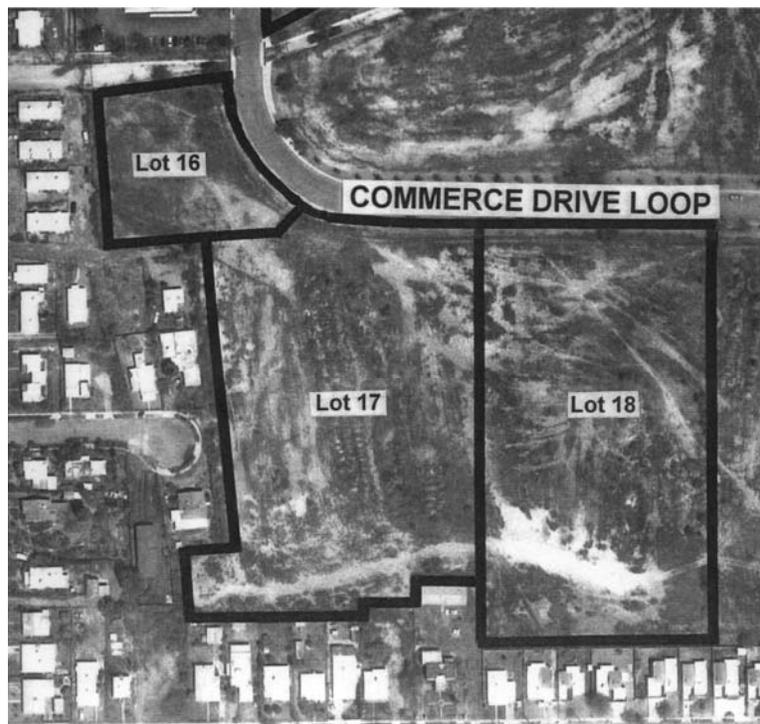
Cooper Aerial Survey Co. 1998

The aerial photographs above and on the front cover show the same portion of the project area over time. In the 1953 photograph one of the deep pits is evident along with two scarp-like features. Stock piles can be seen covering the surface in the 1973 picture. The cover picture shows the current state of the area; leveled with a couple of berms. The berm on the western edge of the property contains little metallic debris while the berm on the eastern is comprised of concrete with rebar. A few smaller piles of metallic debris and concrete are in the lower mid-western portion of the area.

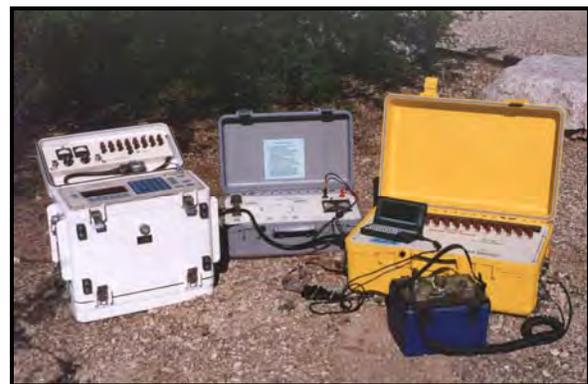
ZETA System: GDP-32, MX-30 and ZT-30

Zonge minimized expenses by utilizing the MX-30 which is a computer-controlled switching interface between a resistivity transmitter, a multi-channel receiver such as the GDP-32, and an array of up to 30 electrodes. All data were acquired in the dipole-dipole configuration with a station-spacing of 7.5 feet and a dipole size of 15 feet. Twelve points were collected along each diagonal ($n=0.5, n=1.0, \dots, n=6$). The electric-field signal was sensed at the receiver site using tin-coated copper braid electrodes. A time domain, 0.5 Hz signal was used, stacking and averaging eight cycles to minimize random noise. All data points were measured at least twice to establish repeatability. A crew of three can acquire 3300 data points plus repeats in one day (2500 linear feet).
