A sewer sinkhole study using TEM

NORMAN R. CARLSON and SCOTT A. URQUHART, Zonge Engineering & Research Organization, Tucson, Arizona, USA

The Leading Edge, #25, March 2006

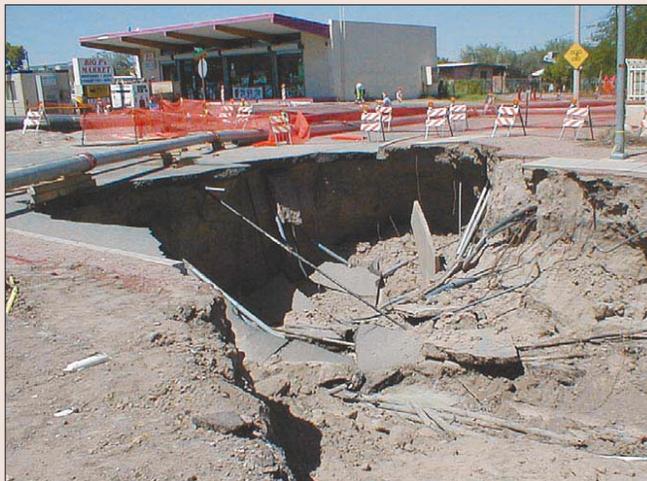
Figure 1. One of two large sinkholes that opened suddenly in the early morning hours of 7 September 2002 on Speedway Avenue in Tucson, USA. The collapse closed the five-lane road for 78 days, causing millions of dollars in damage.

On 7 September 2002, two large sinkholes opened suddenly on a major, five-lane roadway in Tucson (Arizona), USA (Figures 1 and 2). The exact cause of the sinkholes is still controversial, but the sinkholes were apparently related to failures near 90° bends in a 35-year-old, 6-m deep, 1.1-m diameter sewer line known as the outfall interceptor.

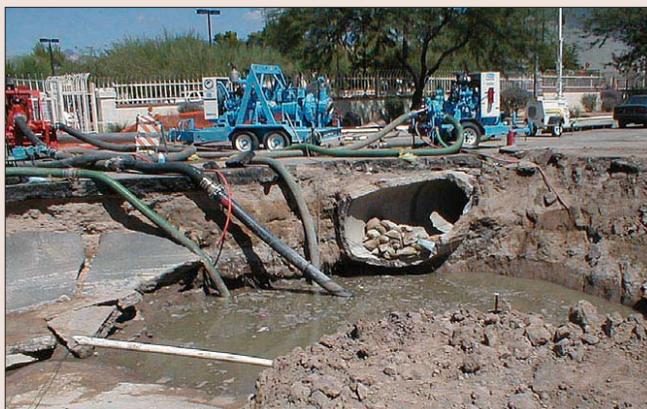
Figure 2. One of the Speedway sinkholes, after partially draining the sewage. When the sinkhole formed, raw sewage flooded the sinkhole and more than 25 million gallons of sewage flowed through a broken storm drain (center of picture, with sandbags) into the Santa Cruz River.

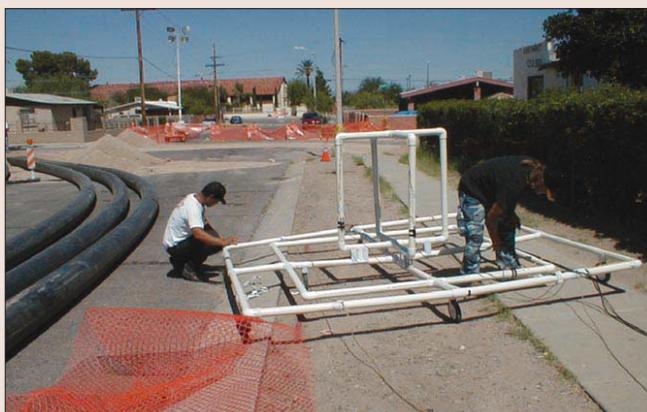
Figure 3. Assembly of the nonmetallic TEM cart during testing. The transmitter loop was 3 × 3 m, and the receiver loops were 2 × 2 m (for the Hz component) and 1 × 1 m (Hx and Hy components). The loop frames were PVC pipe, and the wheels were plastic. The large black plastic pipes on the left are part of the sewage diversion system while the sewer interceptor line was being repaired.

For this TEM survey, a 50% duty cycle, time domain, square wave signal (usually 3 amps) was transmitted into the ungrounded transmitter loop of wire measuring 3×3 m (Figure 3). This square wave signal alternates between positive, zero, negative, and zero voltages, and this cycle repeats 64 times per second. The measurements are made when the transmitter is off (i.e., transmitter voltage is zero). During these times, decaying secondary magnetic fields from subsurface conductors can be measured. In this survey, these magnetic fields are detected with three orthogonal ungrounded square loops of wire, measuring 2×2 m (for the vertical component measurement) and 1×1 m (for the two horizontal measurements). The measurements are made at 31 times (or "windows") after the transmitter is turned off in order to measure the decaying response of the background earth as well as secondary fields from strong conductors (such as metallic objects) after the background earth response has decayed to near-zero values. To minimize random background noise, 32 complete cycles of the waveform are stacked and averaged, constituting one data block. Measurements are made at a rate of about 1 data block every 0.6 s, and at a slow walking pace, this results in one stacked and averaged data block approximately every 0.3-0.5 m. Measurements of all three receiver loops are made simultaneously on three separate A/D channels (i.e., no multiplexing is used) and stored in the digital memory of the receiver. A Trimble Asset Surveyor GPS system, with the antenna mounted above the center of the transmitter loop, provided positioning information.

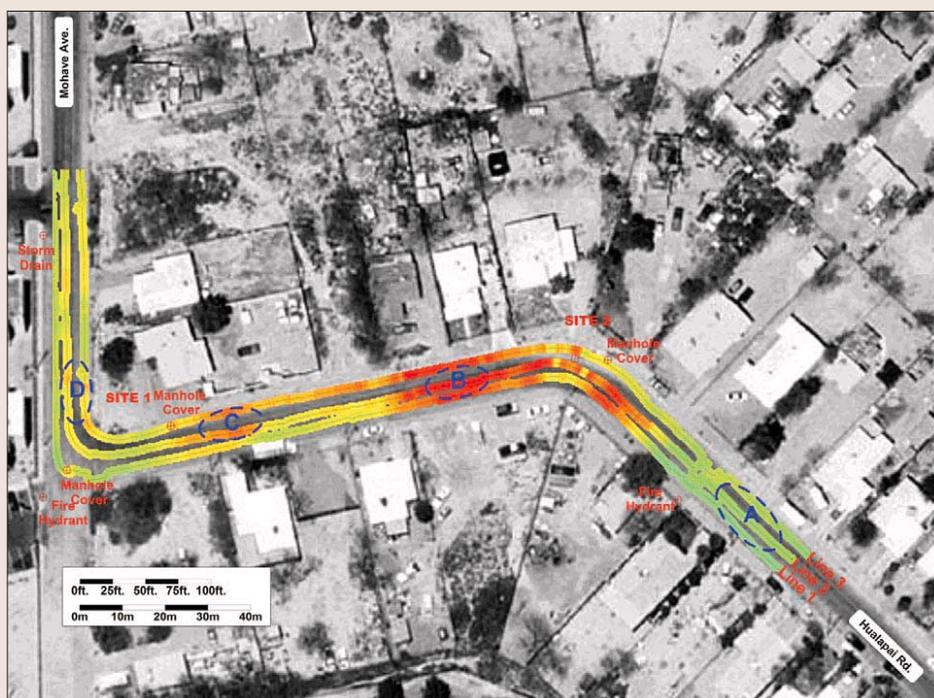
Figure 5. Plan view of the anomalous TEM data on three survey lines along Hualapai Road, using the same color scale for the data as in Figure 4. Dashed ovals labeled A, B, C, and D were areas selected for shallow borehole investigations.

A strongly anomalous area with much lower resistivity than other areas was measured along a section of Hualapai Road, where the sewer interceptor line had two sharp bends in a distance of approximately 125 m (Figure 5). As a result, the survey lines in that area were repeated; background line segments and cultural features were consistent on both surveys, while the anomalous segments remained anomalous but showed a slight decrease in anomaly strength. This observation was expected since flow through the sewer had been reduced to near-zero levels. Based on this data, the city decided to drill shallow boreholes in areas A (as a background region), B, C, and D (as potential target areas) to investigate the source of the anomalous readings (Figure 5).

Upon notification of the city's plan for boreholes, the county decided to investigate this segment of the sewer interceptor line first by running a specialized video camera through the sewer line between the manholes near Site 1 and Site 2 (Figure 5). The camera, aimed upward at the top of the sewer pipe, clearly showed two 5-m segments of the pipe with the top or "crown" dissolved and completely

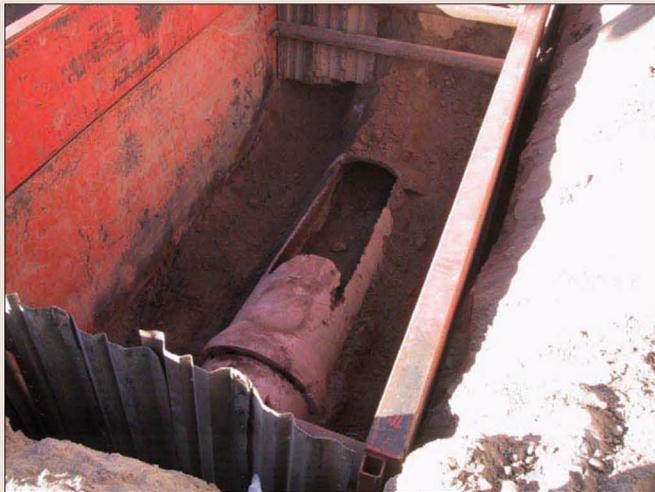
Figure 6. One of the corroded sections of the 42-inch sewer interceptor line in the anomalous segment on Hualapai Road. Enough soil and dirt had fallen into the sewer to create a 2-m void above the sewer line, under the residential street.

missing. Above one segment, the video camera showed a void more than 2 m tall with a natural gas pipeline suspended in the void, just 1 m below the road pavement. The area was immediately closed off and excavated (Figure 6).

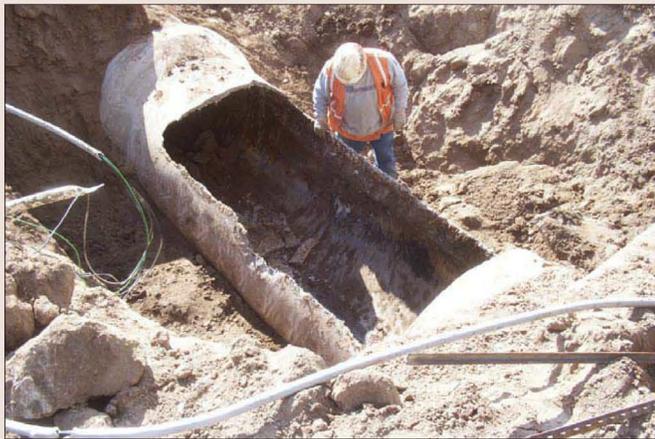
Figure 7. A corroded section of the sewer interceptor line in the Silverbell Golf Course.

After the entire 8 km length of the sewer interceptor line had been surveyed, a long section of the line crossing the Silverbell Golf Course was found to be almost entirely anomalous, and very similar to the data on Hualapai Road. At the same time, investigations by the county with the in-pipe cameras found that stretch of the sewer line so corroded that even golf carts were not allowed to cross over the buried sewer line (Figure 7).
