# **Managing Our Water Retention Systems**

# USING GEOPHYSICS TO EVALUATE AN EMBANKMENT DAM SINKHOLE

Located near Knoxville, Tennessee, Chilhowee Dam is 80 feet high and 1,500 feet long with two embankment sections, a concrete gated spillway, and two concrete non-overflow sections. A six-foot deep sinkhole formed near the left abutment on the upstream slope of the Chilhowee Dam's embankment in February 2000. Geotechnical investigations were performed to evaluate the sinkhole, including borings, test pits, instruments, and geophysics. The dam posed two distinct challenges to a geophysical investigation: 1) a very complex geometry of the embankment with upstream sloping clay core, many filters each side of the clay, rockfill shells, and a steeply sloping rock foundation contact; and, 2) restrictions from the hydro power generation at the dam. The focus of this presentation is the multiple surface geophysical methods used for subsurface evaluation to help determine dam remediation.

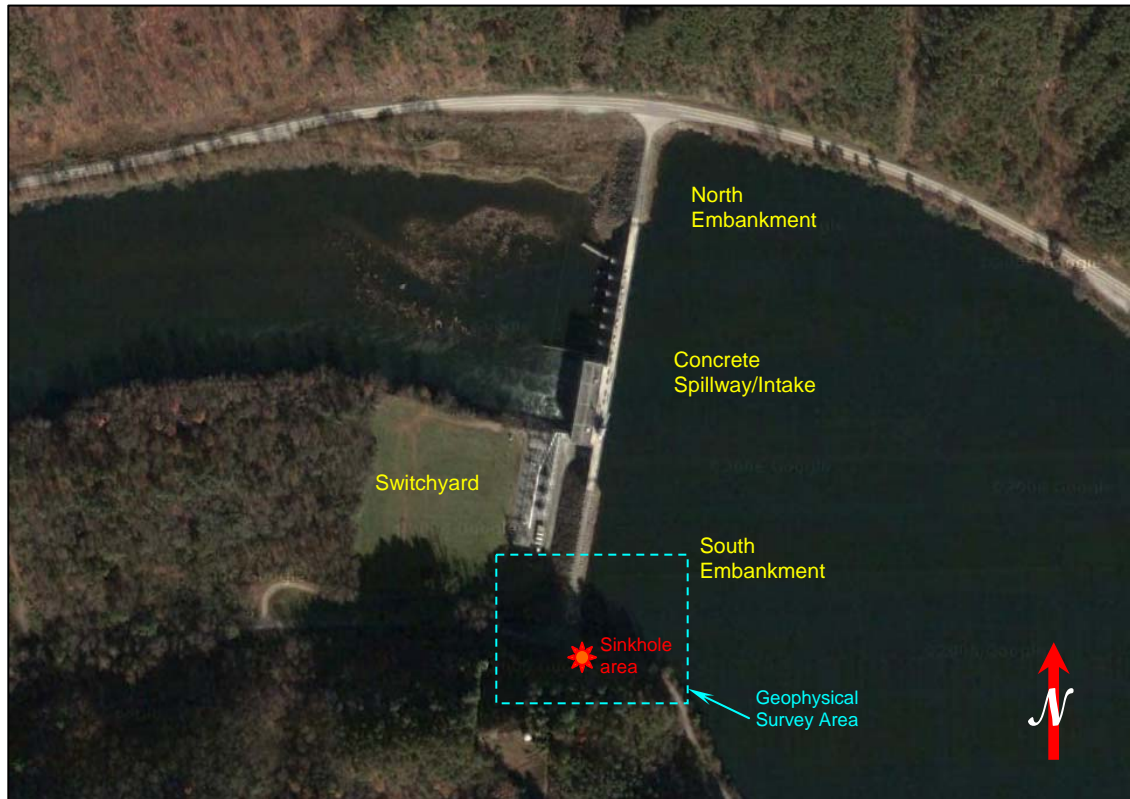
Chilhowee Dam is located near Knoxville, Tennessee on the Little Tennessee River. It was constructed in 1957, and is 80 feet high and 1,500 feet long with two rockfill embankment sections, a concrete gated spillway, an integral powerhouse, and two concrete non-overflow sections (Figure 1).

Figure 1. Aerial Photo of Chilhowee Dam Identifying Sinkhole Location and Geophysical Survey Location (Photo source: Google Maps)

In February 2000, a six-foot deep sinkhole formed in the embankment near the left abutment at the intersection of the crest and upstream slope. The location of the sinkhole is shown in Figure 1.

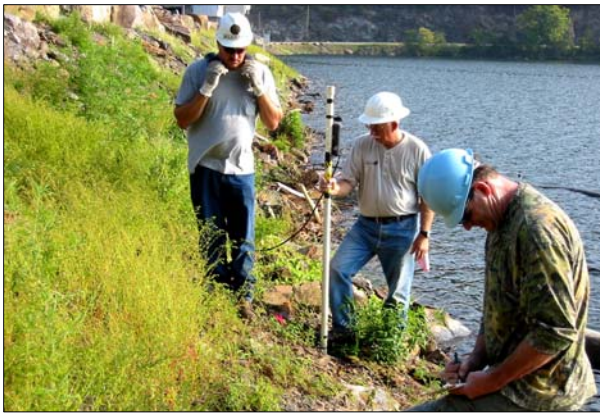
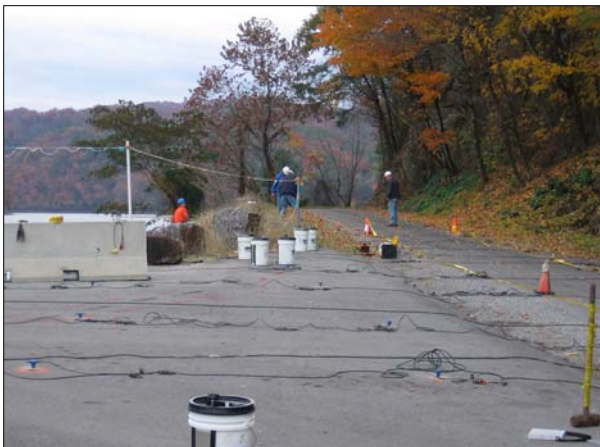
Photos: SP upstream embankment slope (left); SP off-shore (right); Seismic on crest road (bottom)

The off-shore (in the reservoir) SP survey was performed similarly to the on-shore SP survey, but from a boat (see middle inset photo below), and using underwater electrodes. During the normal pool SP survey, the off-shore SP data were collected along traverses spaced about 20 feet apart and oriented approximately parallel to the dam axis, as shown in Figure 3. SP readings were taken at regular time intervals as the boat advanced along

For the seismic analyses, 120 channels were used to acquire sufficient coverage to surround the sinkhole area. That is, 120 14-Hz geophones were placed on the ground in a 10-foot by 10-foot grid, with all geophones recording each seismic energy source (see right inset photo). Geophone positions used the same locations that were occupied during the SP survey. A 16-pound sledge hammer was used on an aluminum block as the seismic source to impart an impulsive energy source. P-wave signals were generated when the hammer struck the aluminum block. The block provides good coupling to the ground and good transfer of consistent energy.
