Detection of Structural Components and Seepage Zones at the Eagle Mountain Facility Using Geophysics

**ASDSO 2010
Seattle, WA**

Eagle Mt. Dam & Lake

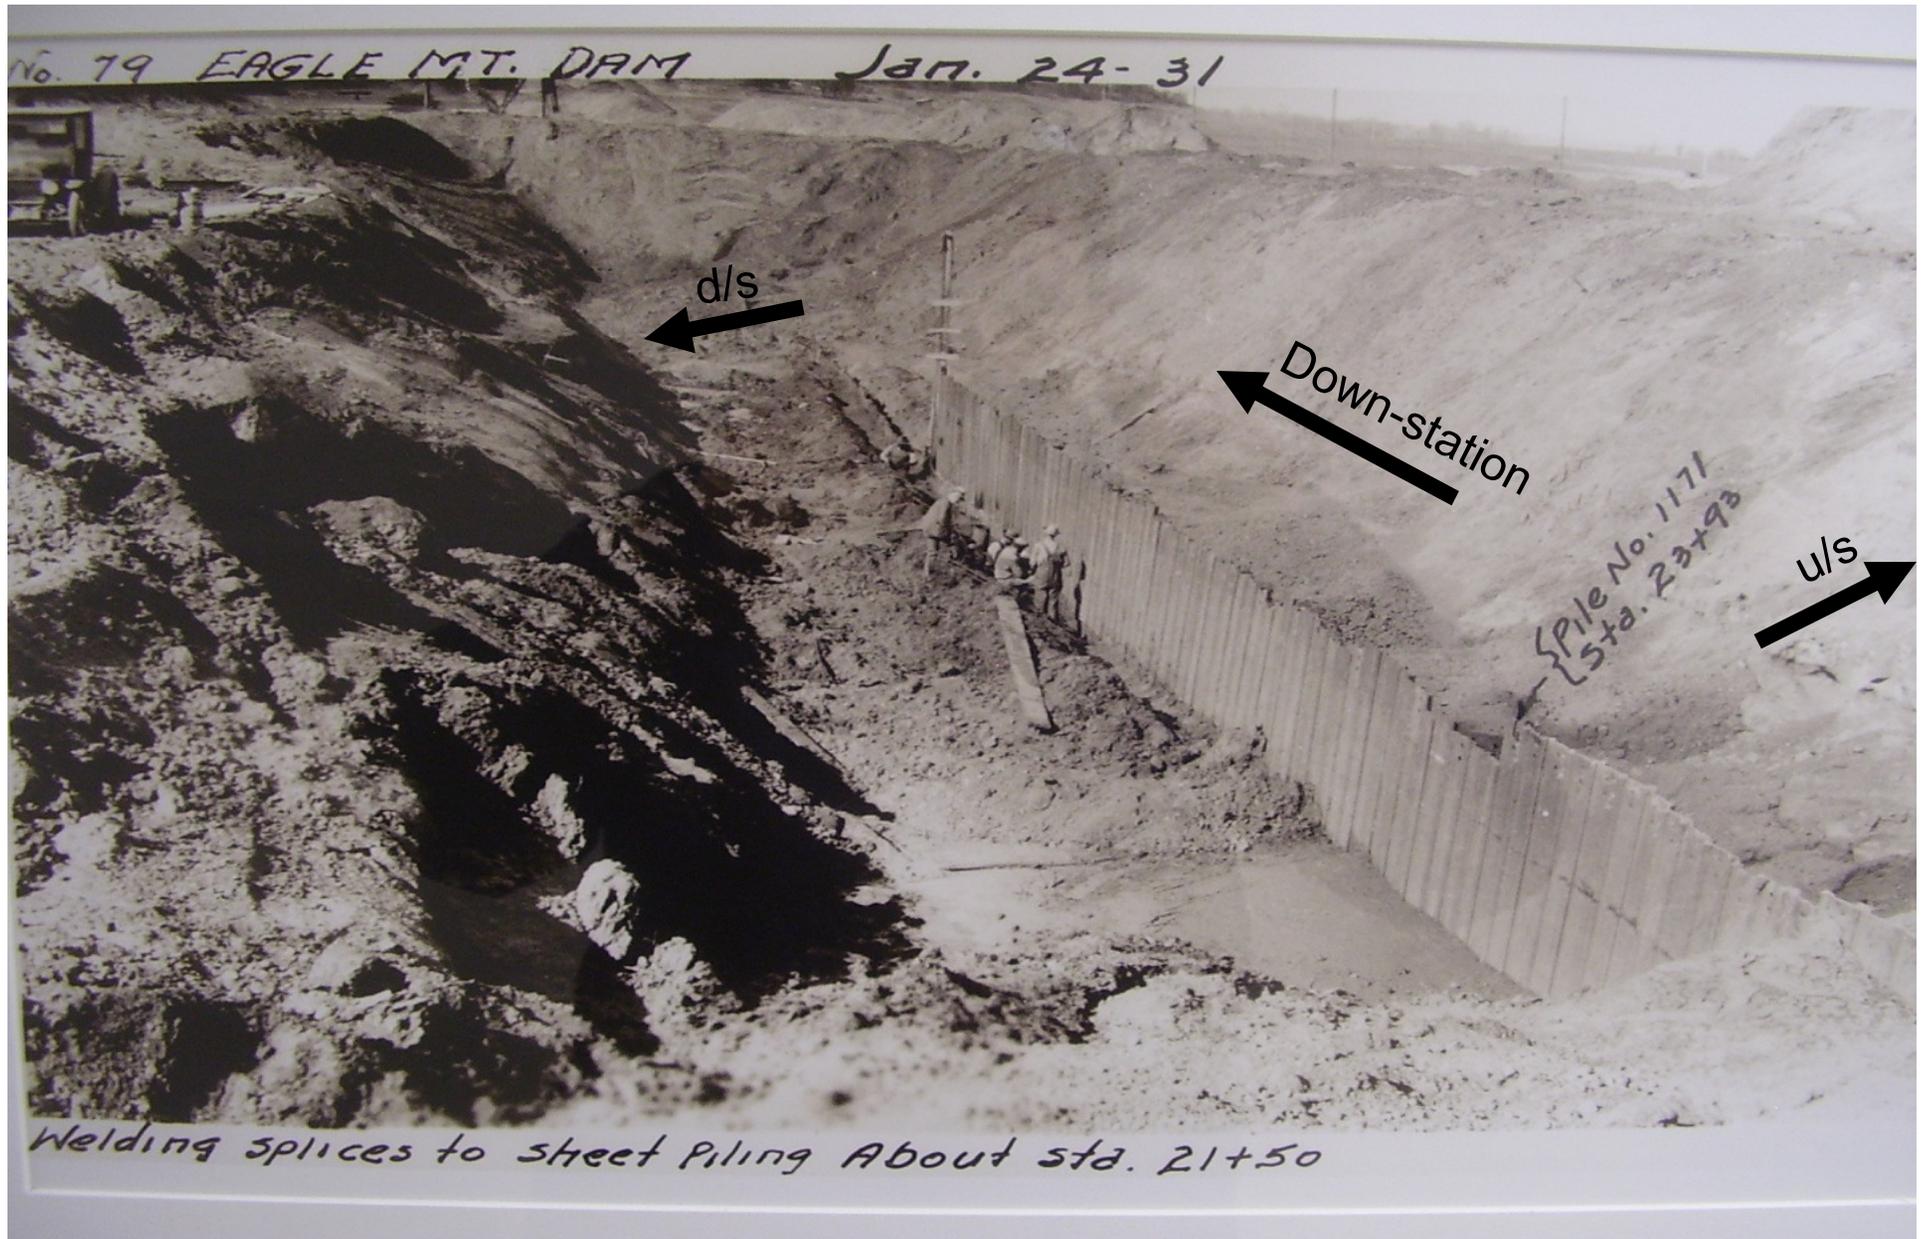
Historical Record – Main Dam

“For past several decades Green-Spots and the ponds downstream are recharged.” * Ongoing monitoring programs culminated into a comprehensive geotechnical review and investigation led by PB World.

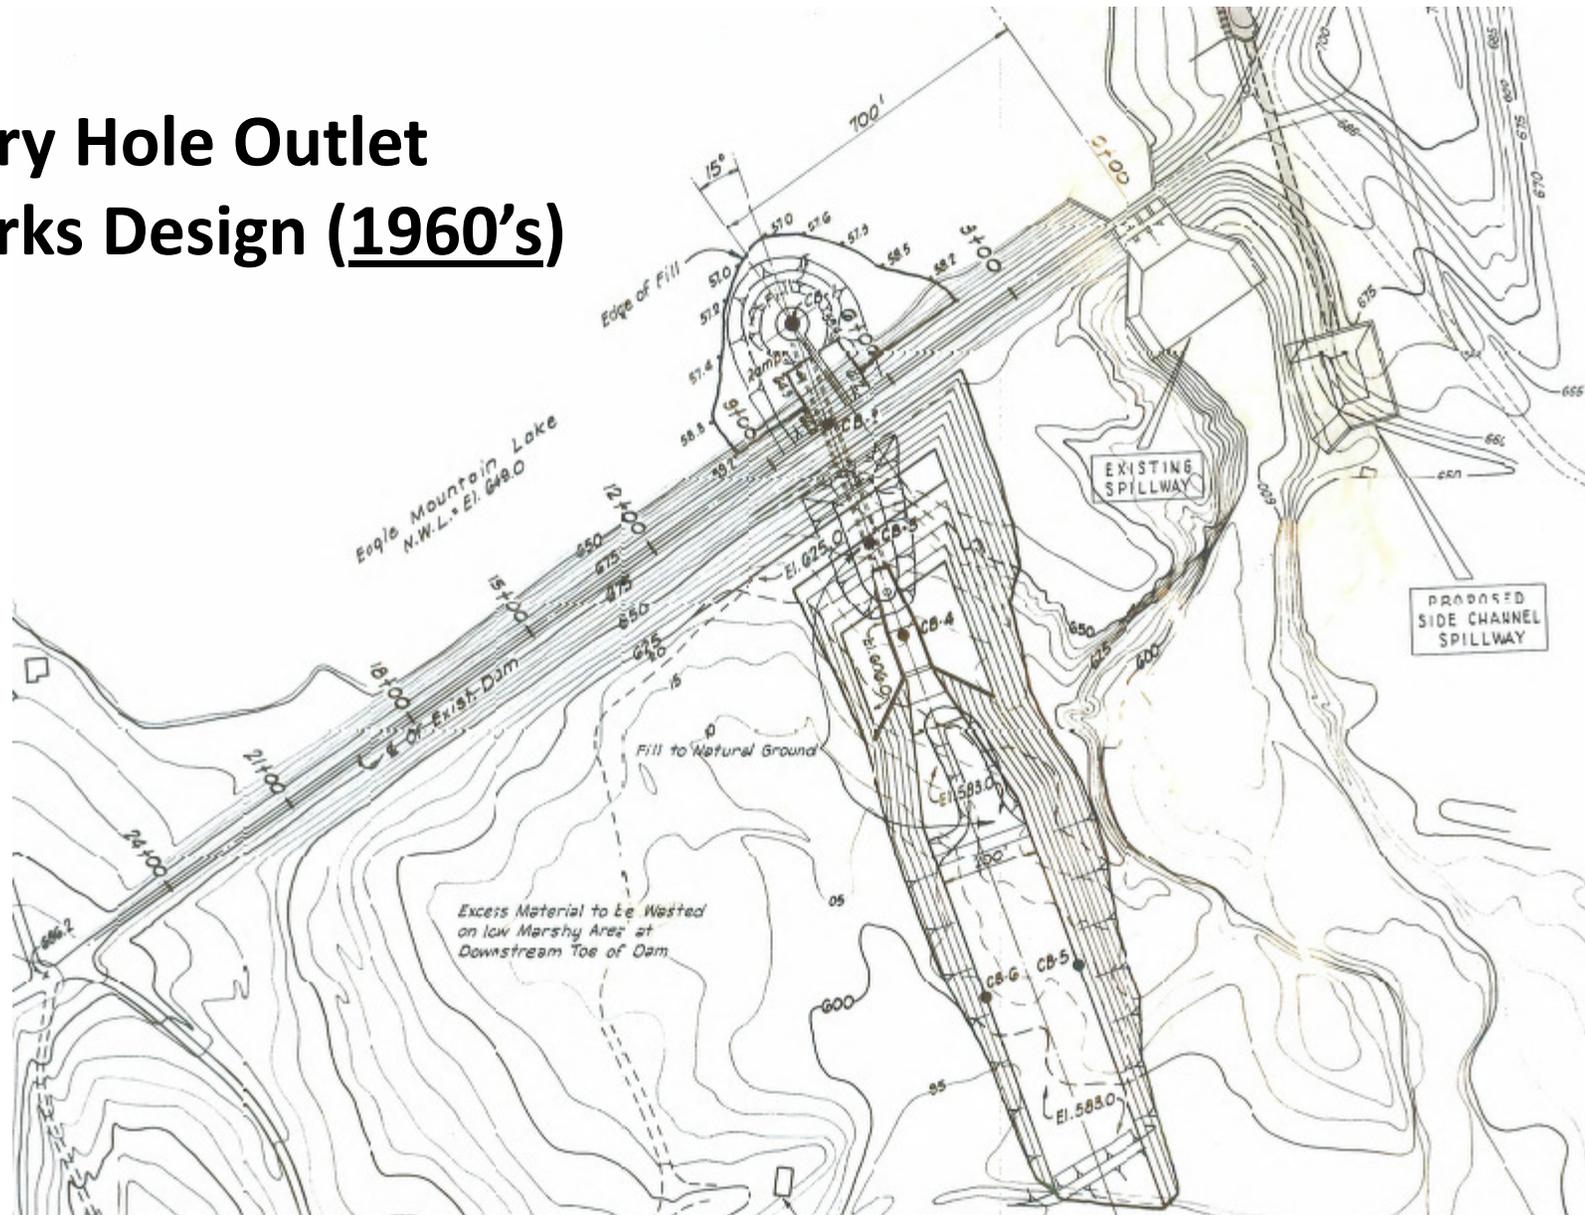
Glory Hole Outlet Works Design (1960's)

“The morning glory spillway’s inlet shaft was nearly completely built (u/s). But they encountered difficulties the deeper they extended the shaft. Seepage was the main issue, grouting **and** freezing was largely unsuccessful.

Simultaneously, the downstream portion of the channel was excavated into the levee embankment. The cut into the levee produced uncontrollable flow from at least one cavity at the levee’s toe.”
